MSFC-815

MISSE Thermal Control Materials with Comparison to Previous Flight Experiments

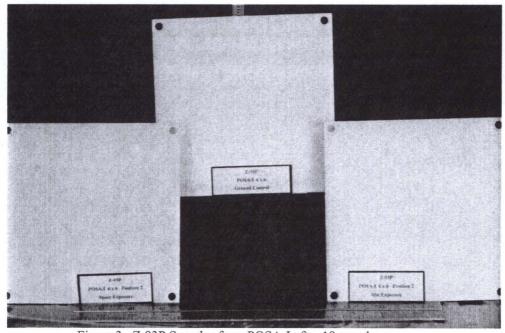
When contamination is minimal (300Å or less), as in the case of LDEF, OPM, and the Mir-facing side of POSA-I, Z-93, Z-93P, and AZ93 maintain solar absorptance close to that of beginning-of-life. When heavier levels of contamination are present, these inorganic white coatings become yellowed or tan, with corresponding higher solar absorptance (fig. 3). For example, Z-93P on the space-facing side of POSA-I received approximately 5,000Å of silicone contamination but only 571 ESH of UV, and its solar absorptance increased from 0.16 to 0.23. Ground tests of pre-contaminated zinc oxide/potassium silicate indicated much higher solar absorptances with increased UV exposure.

Figure 3. Z-93P Samples from POSA-I after 18 months exposure Left, space-facing with ~5,000Å silicone contamination, center, control sample, right, Mir-facing with ~250 Å silicone contamination.

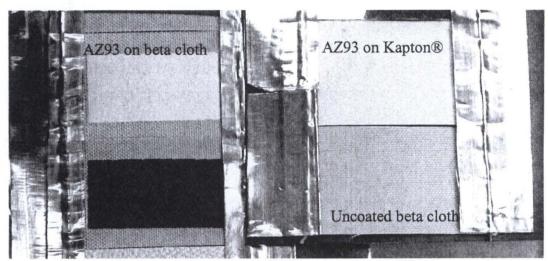
MISSE-5 had over 200 materials samples attached to the nadir side as part of the insulation blanket. Because of the configuration, samples had to be thin and flexible. AZ93 was sprayed on beta cloth and Kapton® substrates in a nominally 2-mil thick layer, much thinner than would normally be applied to aluminum (5 mils). The result is a higher beginning-of-life solar absorptance for these samples.

Figure 4 is of the AZ93 on beta cloth from MISSE-5. The beta cloth around the AZ93 has darkened, and enough UV may have been transmitted through the AZ93 to also darken the substrate beta cloth.

Figure 4. AZ93 coatings on flexible substrates on MISSE-5. Beta cloth has darkened with exposure to UV, AZ93 is nominally white.
